New Hampshire Volunteer Lake Assessment Program

2003 Biennial Report for Little Sunapee Lake New London

Little Lake Sunapee, New London

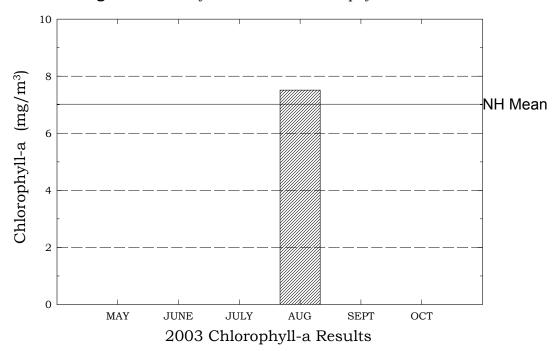
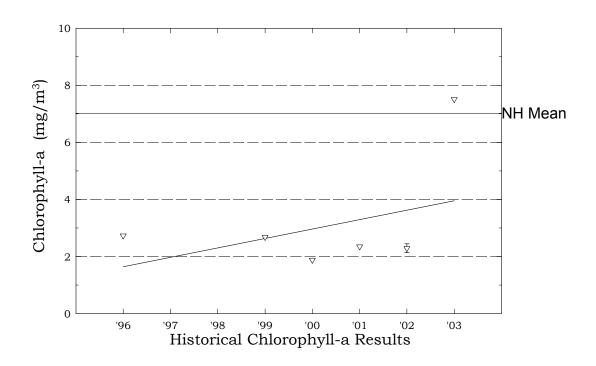
Figure 1. Monthly and Historical Chlorophyll-a Results

Figure 1 and Table 1: The graphs in Figure 1 (Appendix A) show the historical and current year chlorophyll-a concentration in the water column. Table 1 (Appendix B) lists the maximum, minimum, and mean concentration for each sampling season that the lake has been monitored through the program.

The current year data (the top graph) show that the chlorophyll-a concentration in August was **approximately equal to** the state mean.

The historical graph (the bottom graph) shows that the 2003 chlorophyll-a mean is *approximately equal to* the state mean.

Overall, visual inspection of the historical data trend line (the bottom graph) shows *a relatively stable* in-lake chlorophyll-a trend (with this year as an exception), meaning that the concentration has *remained approximately the same* since monitoring began. After 10 consecutive years of sample collection, we will be able to conduct a statistical analysis of the historic data to objectively determine if there has been a significant change in the annual mean chlorophyll-a concentration since monitoring began. Collecting additional samples each year will help us to better understand the chlorophyll levels throughout the summer.

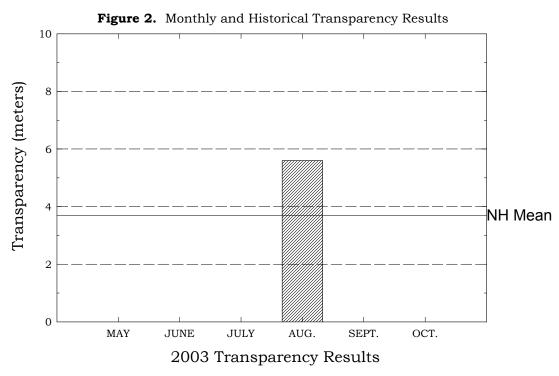
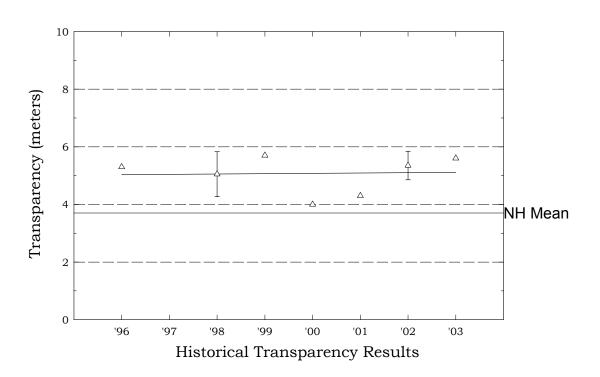
Figure 2 and Table 3: The graphs in Figure 2 (Appendix A) show historical and current year data for lake transparency. Table 3 (Appendix B) lists the maximum, minimum and mean transparency data for each sampling season that the lake has been monitored through the program.

The graphs show that the in-lake transparency in August was **greater than** the state mean.

Overall, visual inspection of the historical data trend line (the bottom graph) shows **a stable** trend for in-lake transparency, meaning that the transparency has **remained approximately the same** since monitoring began. After 10 consecutive years of sample collection, we will be able to conduct a statistical analysis of the historic data to objectively determine if there has been a significant change in the annual mean transparency since monitoring began.

Typically, high intensity rainfall causes erosion of sediments into lakes/ponds and streams, thus decreasing clarity. Efforts should continually be made to stabilize stream banks, lake shorelines, disturbed soils within the watershed, and especially dirt roads located immediately adjacent to the edge of tributaries and the lake. Guides to Best Management Practices designed to reduce, and possibly even eliminate, nonpoint source pollutants, such as sediment loading, are available from DES upon request.

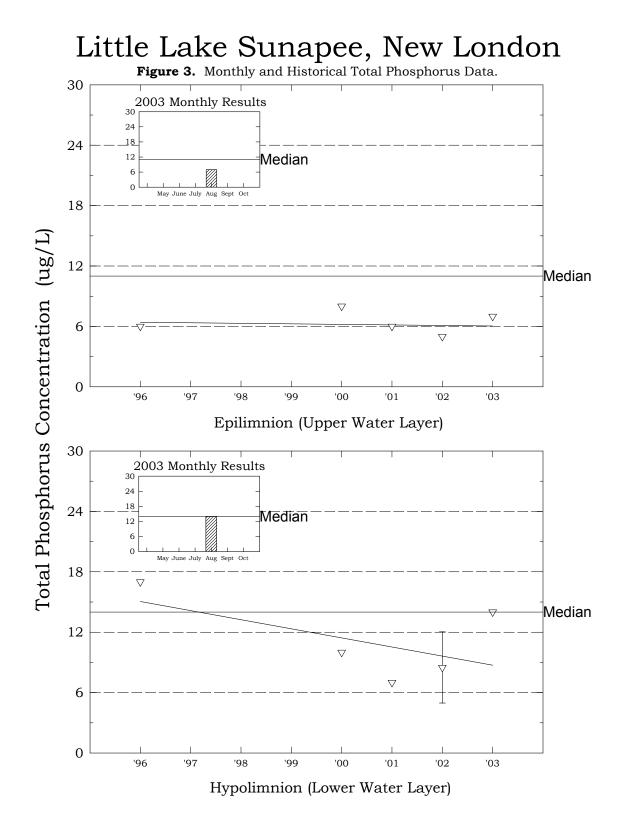
Figure 3 and Table 8: The graphs in Figure 3 (Appendix A) show the amounts of phosphorus in the epilimnion (the upper layer) and the hypolimnion (the lower layer); the inset graphs show current year data. Table 8 (Appendix B) lists the annual maximum, minimum, and median concentration for each deep spot layer and each tributary since the lake joined the program.

The graphs for the epilimnion (the top graphs) show that the phosphorus concentration in August was *less than* the state median.

The graphs for the hypolimnion (the bottom graphs) show that the phosphorus concentration in August was **equal to** the state median.

Overall, visual inspection of the historical data trend line for the epilimnion shows **a relatively stable** phosphorus trend, which means that the concentration has **remained approximately the same** in the epilimnion since monitoring began.

Overall, visual inspection of the historical data trend line for the hypolimnion shows *a variable* phosphorus trend, which means that

the concentration has *fluctuated* in the hypolimnion since monitoring began.

One of the most important approaches to reducing phosphorus loading to a waterbody is to continually educate watershed residents about its sources and how excessive amounts can adversely impact the ecology and value of lakes and ponds. Phosphorus sources within a lake or pond's watershed typically include septic systems, animal waste, lawn fertilizer, road and construction erosion, and natural wetlands.
